HOOSIC RIVER BASIN
NORTH ADAMS, MASSACHUSETTS

ECLIPSE DAM
MA 00279

PHASE I INSPECTION REPORT
NATIONAL DAM INSPECTION PROGRAM

MARCH 1980

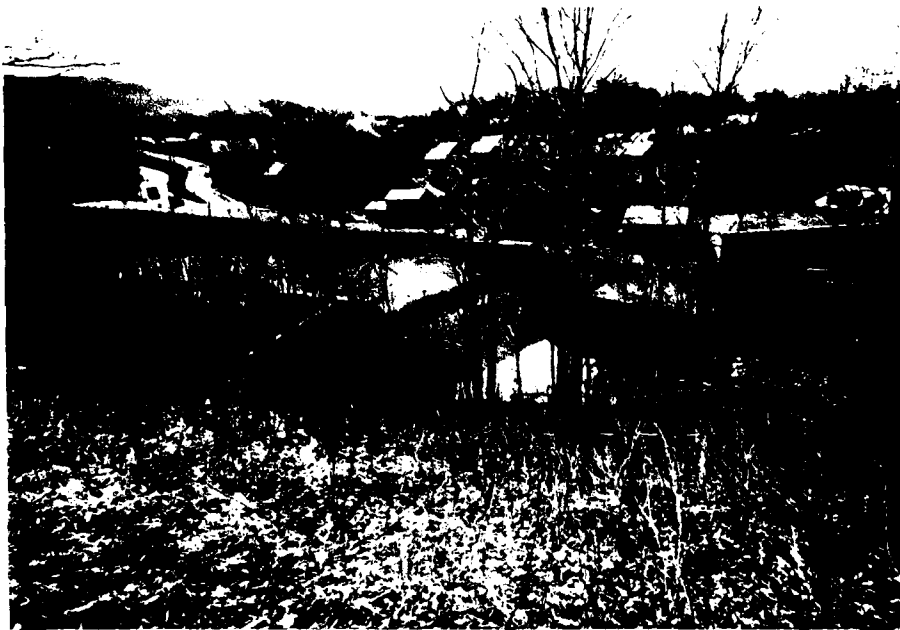
1. OVERVIEW OF DAM FROM RIGHT SIDE

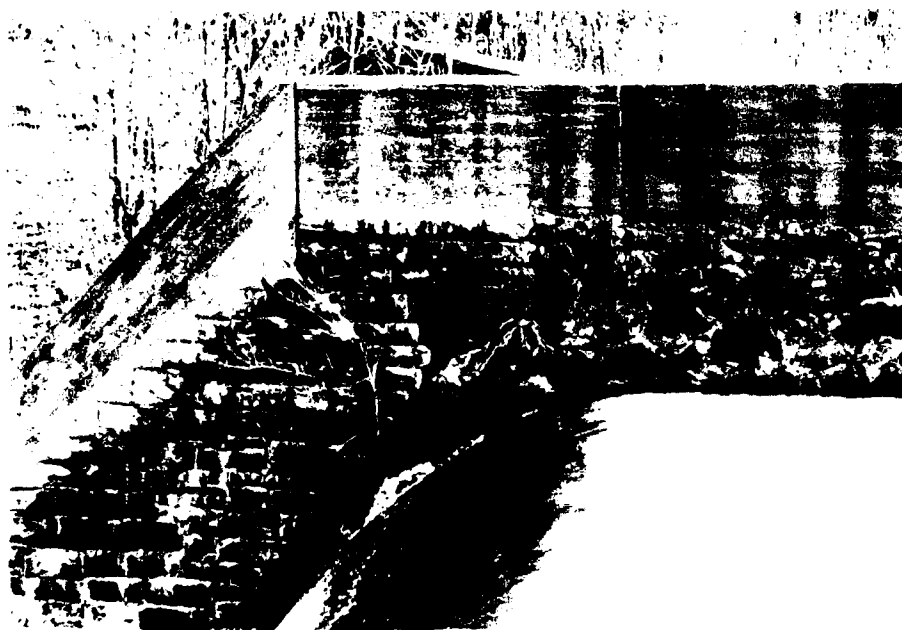
- (3) Several very small trees are growing in the masonry open joints of the spillway sidewalls as indicated in Photo 3.
- c. Appurtenant Structures - The outlet works shown in Photo 7 was found to be in good condition except that the 48-inch sluice gate was not operable due to an electrical problem. The power utility repair crew was called during the inspection and were at work on the problem at the time of departure of the inspection team. One panel of grating has been replaced with steel plate at the operating platform as shown in Photo 8.

3. SPILLWAY RIGHT SIDE WALL WITH CONCRETE DAM IN BACKGROUND.
NOTE VOIDS AND TREE GROWTH IN SIDE WALL.

- (3) Remove small trees and vegetation from the stone masonry training walls.
- (4) Replace missing stones and mortar joints of loose stones in the exposed stone masonry.

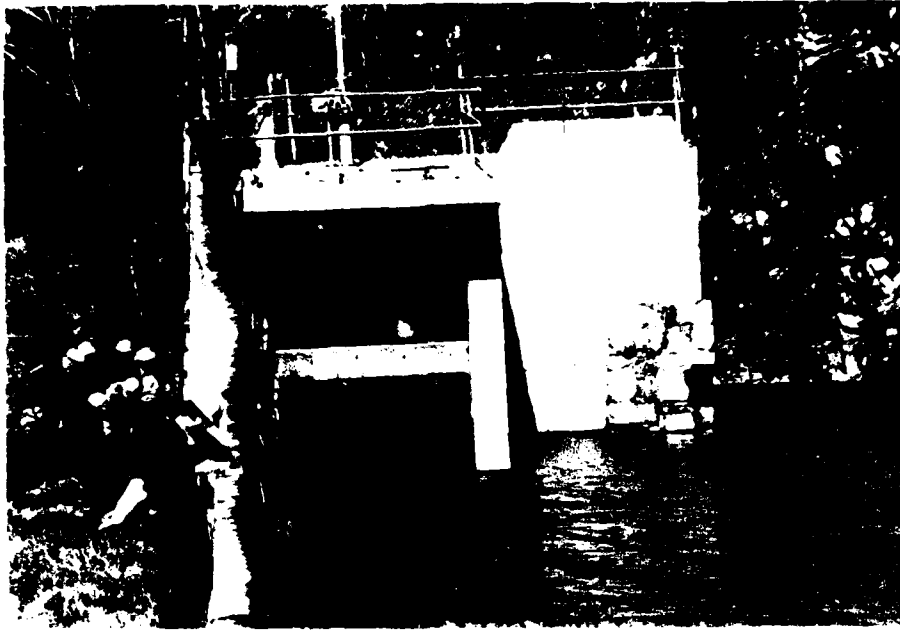
The upstream channel left wall was found to be in very good condition but the top of the wall has a very poor alignment as shown in Photo 7. The poor alignment may be due to poor construction or due to differential deflection of the wall. No cracking or distress was observed that would indicate the problem is one of deflection.

7. TELEPHOTO VIEW OF OUTLET WORKS. NOTE ALIGNMENT OF LEFT UPSTREAM CHANNEL WALL.

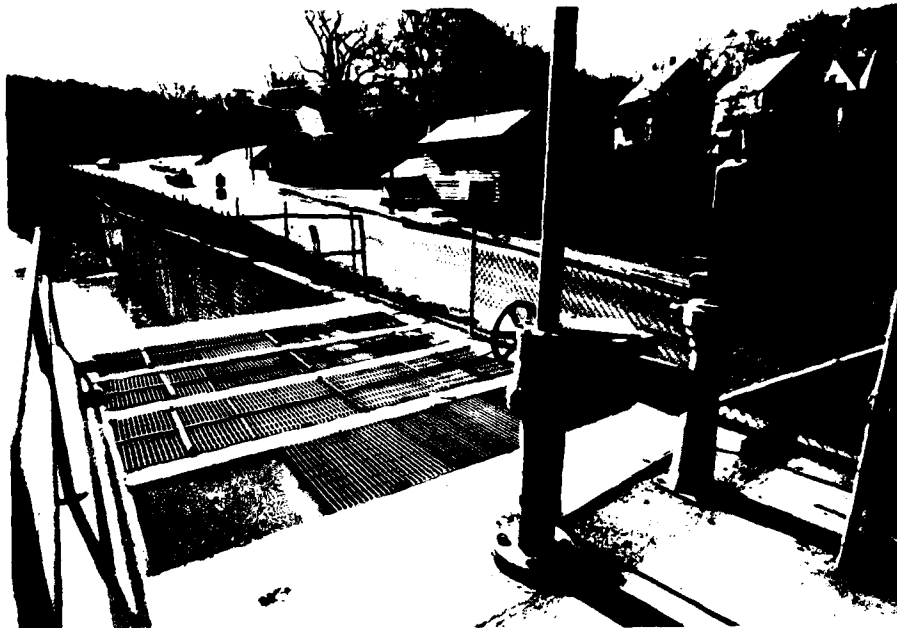
8. VALVE OPERATORS ON OUTLET WORKS PLATFORM.

- (5) Replace the steel plate on the operating platform with a grating panel.
- (6) Repair any eroded areas of ledge adjacent to the foundation of the downstream walls with concrete.

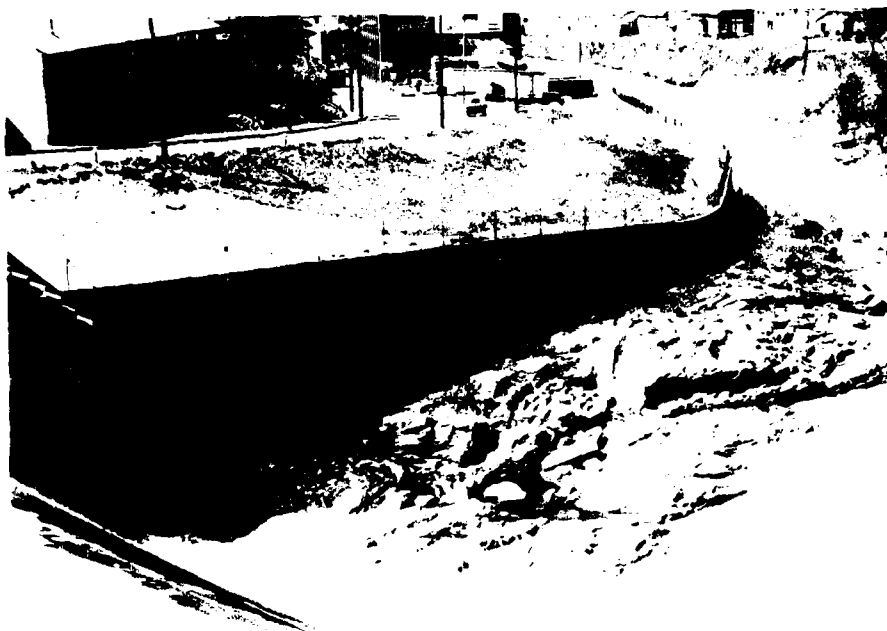
10. DOWNSTREAM CHANNEL. DISCHARGE PIPE FROM OUTLET
WORKS AT END OF CONCRETE WALL LEFT SIDE OF PHOTO.

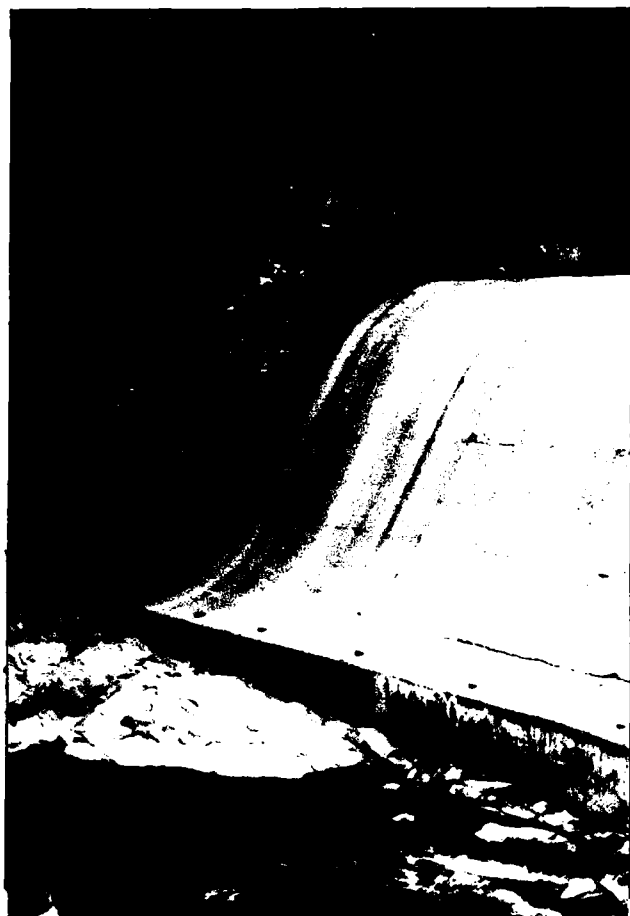
12. DOWNSTREAM FACE OF WEIR WITH NO
FLOW OVER SPILLWAY, PHOTO TAKEN
6 AUGUST 1979.
